Rehabilitation Programme

FACT SHEET

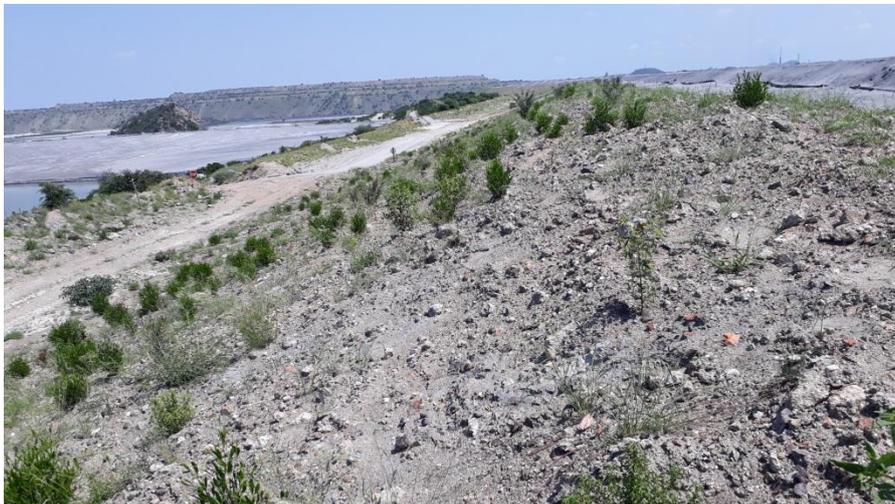
The method used to revegetate these areas is simple, yet very effective. The dams and waste rock dumps are formed with terraces of approximately 5m lifts. As new lifts are completed, they are capped with vermiculite waste material (fine waste produced by Palabora's vermiculite production) to a depth of between 250 and 300mm. Once capping is complete, the lifts are fertilised and seeded. Any bare patches appearing within the vegetation's growth after seeding can be repaired by a second treatment. Some of the grass seeds used in the seeding process are *Eragrostis tef*, *Anthephora pubescens*, *Cynodon dactylon*, *Cenchrus ciliaris*, *Panicum maximum*, *Digitaria eriantha* and *Chloris gayana*.

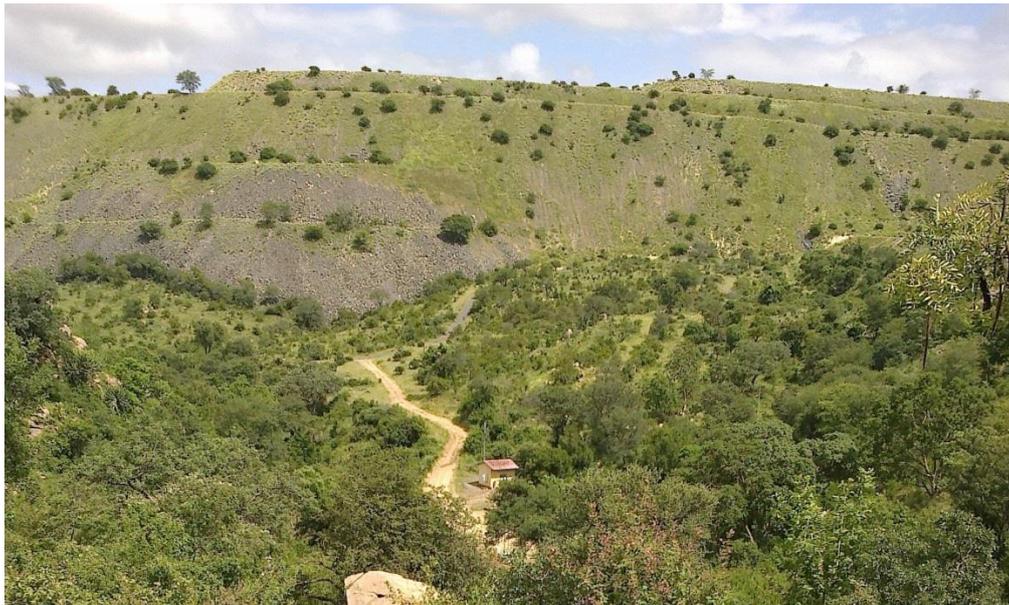
Once the new grass has germinated it is carefully monitored and maintained in order to achieve a satisfactory, self-sustaining cover on the lifts. The parameters that are taken into account when monitoring are: species composition and number of plants, vigour and basal cover. These help to determine whether the revegetation programme is working and whether any changes need to be made to improve it. To date, Palabora has rehabilitated an area of approximately 400ha.
